# REASONS FOR THE COLLAPSE OF CEILINGS DURING THE CONSTRUCTION OF MONOLITHIC BUILDINGS

Tomakov M.V., Pykhtin A.I., Tomakov V.I., Tomakova I.A.

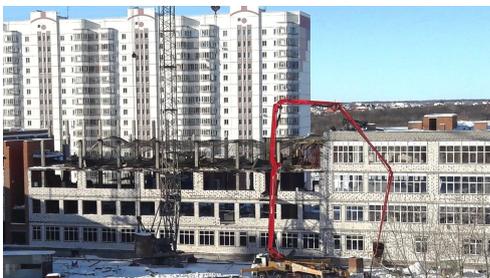
In Kursk, on 19.01.2019, during construction work in the new school building, the formwork could not withstand the weight of concrete. The slab collapsed all around the perimeter. The area of the collapse amounted to 400 sq. m. The consequences of the accident are shown in Fig.1.

Figure 1: The Collapse of the floor slab during the construction of a school building in Kursk
